SECONDARY MINERAL ALTERATION

RESEARCH REPORT

NO. M & R 632425

FINAL REPORT
on
SECONDARY MINERAL ALTERATION
of
AGGREGATE BASE AND SUBBASE

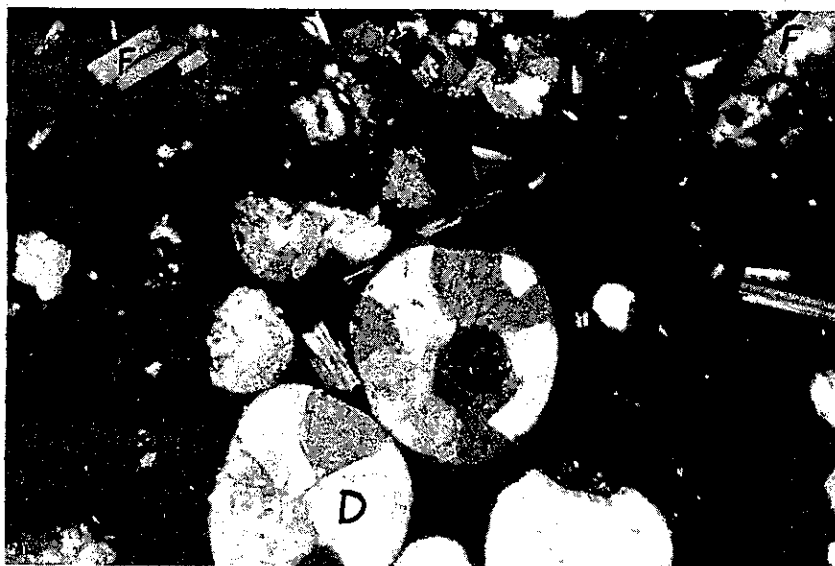
Photo 2 - Malibu Lake Streambed 63-2186 #2 X 100
Dolomite amygdules in groundmass of
hematite. Note scattered feldspar laths.

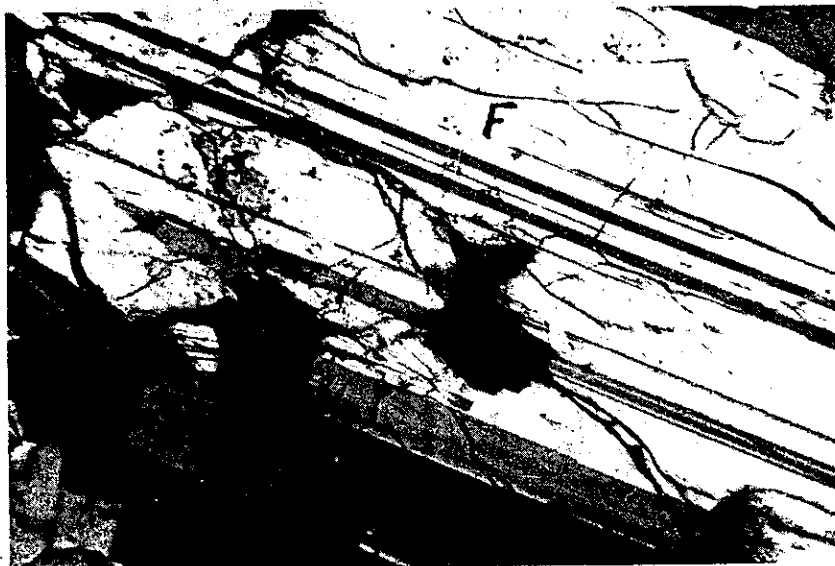
Photo 3 - Malibu Lake Streambed 63-2186 #4 X 100
Fractured plagioclase lath in porphyritic
trachyte.

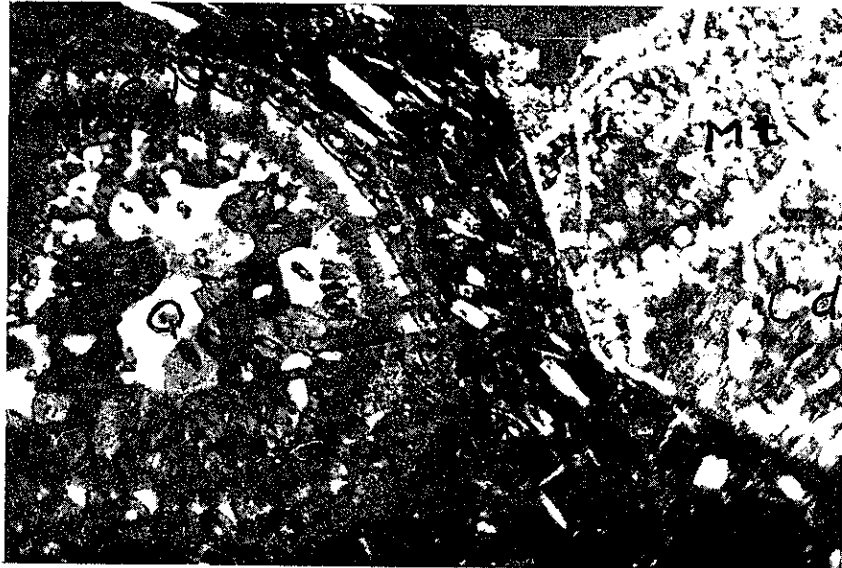
Photo 5 - Malibu Lake Streambed 63-2186 #4 X 100
 Amygdules consisting of a rim of sperulitic
 chalcedony with a core of cryptocrystalline
 quartz. Note dark glassy groundmass and
 relict amphibole altered to chalcedony with
 montmorillonite-filled fractures. X-Nic.

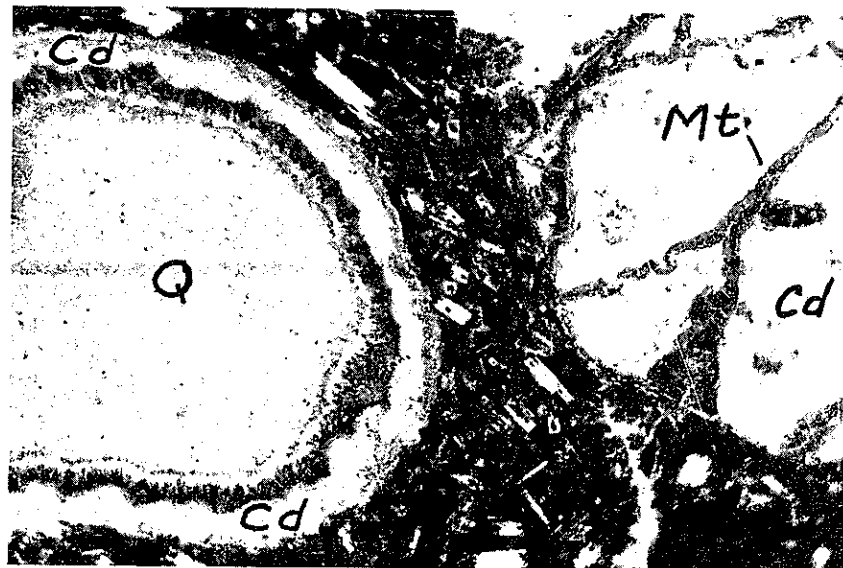
Photo 6 - Same as above but in plain polarized light.

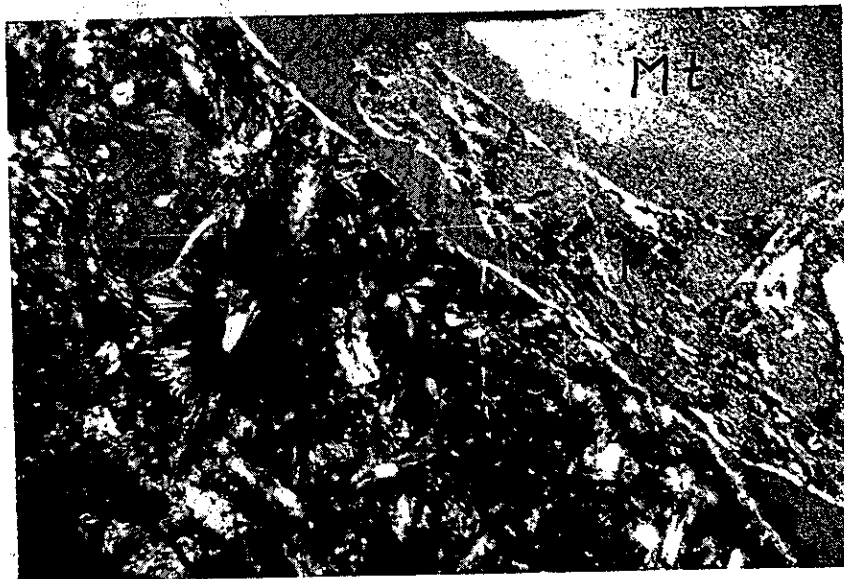
Eight of the 23 volcanic samples contained devitrified volcanic glass and/or palagonite. Alteration of glass to palagonite with the accompanying hydration may result in swelling and may possibly be a cause of degradation in itself. Construction materials containing volcanic glass or its altered product therefore are undesirable for highway construction purposes because of the potential degradation and alkali reaction properties.

Photo 7 - Malibu Lake Streambed 63-2186 #5 X 100
Volcanic glass with spherulites, largely
altered to palagonite. Montmorillonite in
upper right hand corner.

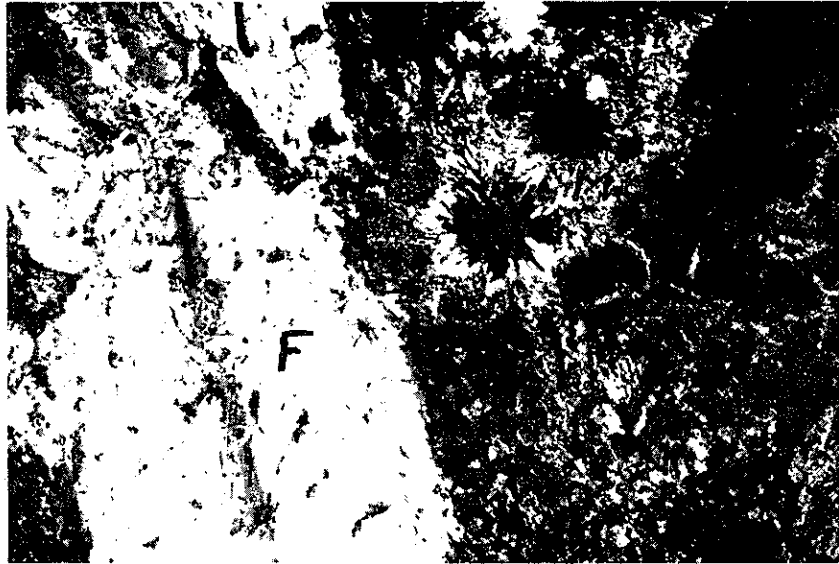
Photo 9 - South Mtns. Creek Bed 63-2188 #1 X 100
Crystalline montmorillonite and corroded
feldspar.

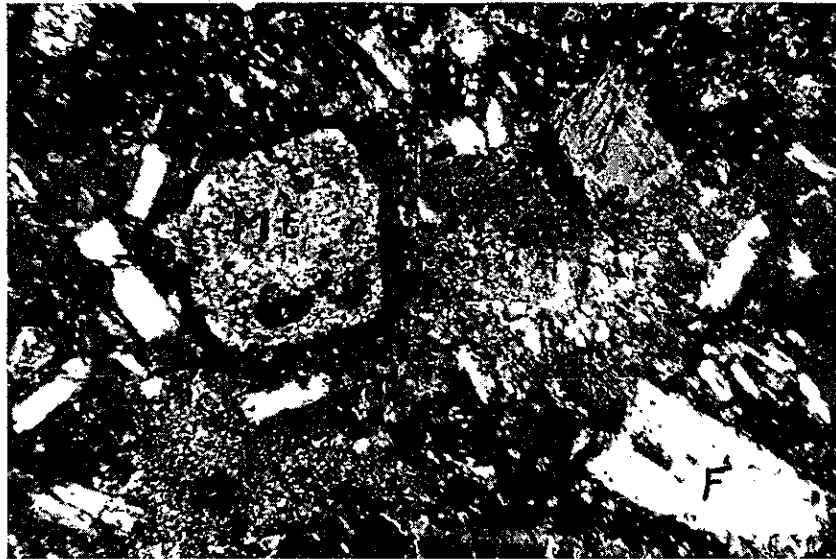
10. Complete replacement of relict amphibole by montmorillonite.
11. Olivine altered to iddingsite in basalt.
12. Relict pyroxene crystal altered to montmorillonite.

Photo 10 - South Mtns. Creek Bed 63-2188 #1 X 100
Complete replacement of relict amphibole
by crystalline montmorillonite.

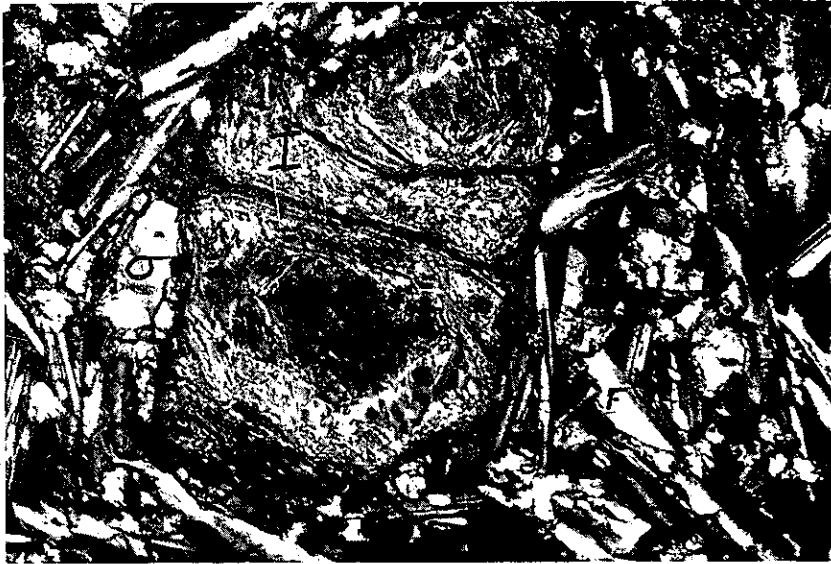
Photo 11 - South Mtns. Creek Bed 63-2188 #4 X 100
Olivine altered to iddingsite in basalt.

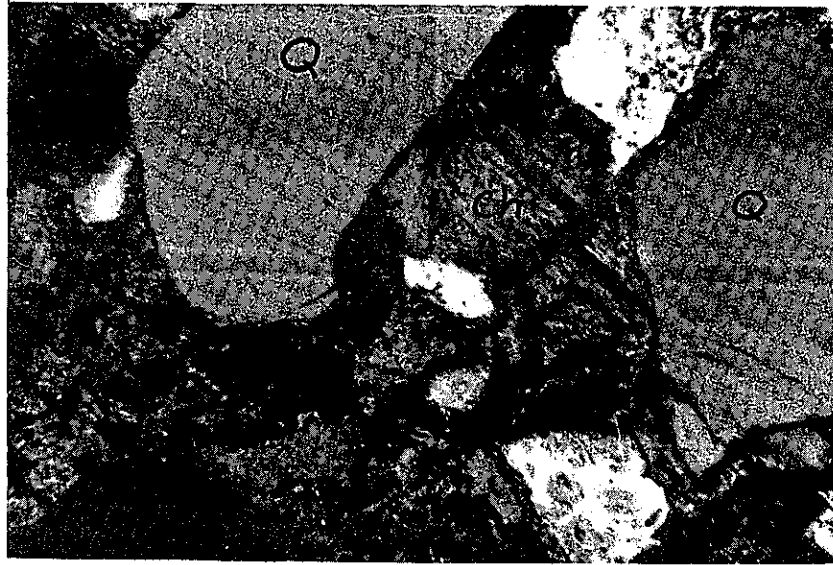
Photo 13 - Toro Point Sandstone 65-2053 X 100
Chloritized biotite between two large
quartz grains.

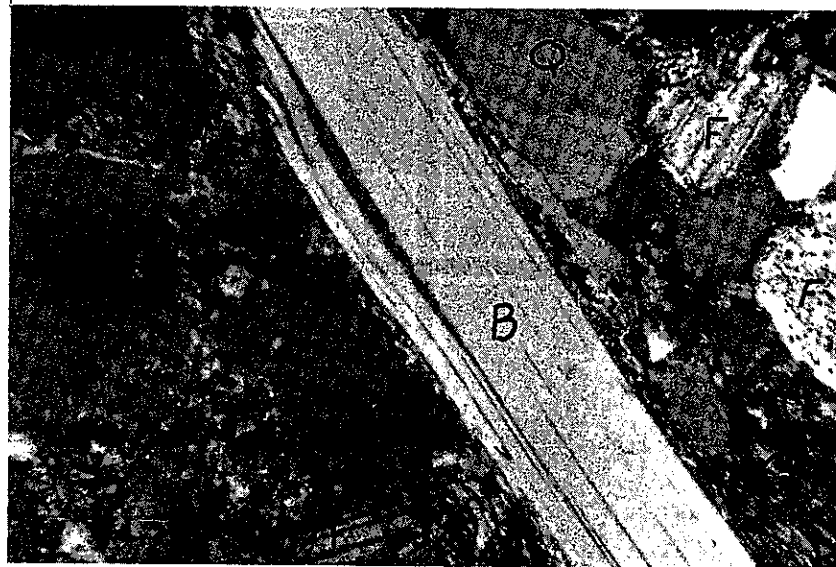
4. Degradation of the Toro Point sandstone after being crushed and stockpiled was attributed to a breakdown of the chlorite-sericite² matrix and an inherent tendency to part along planes of bedding.

Photo 14 - Toro Point Sandstone 65-2053 X 100
Biotite, quartz, feldspar, magnetite and
shale in chlorite-sericite? matrix.

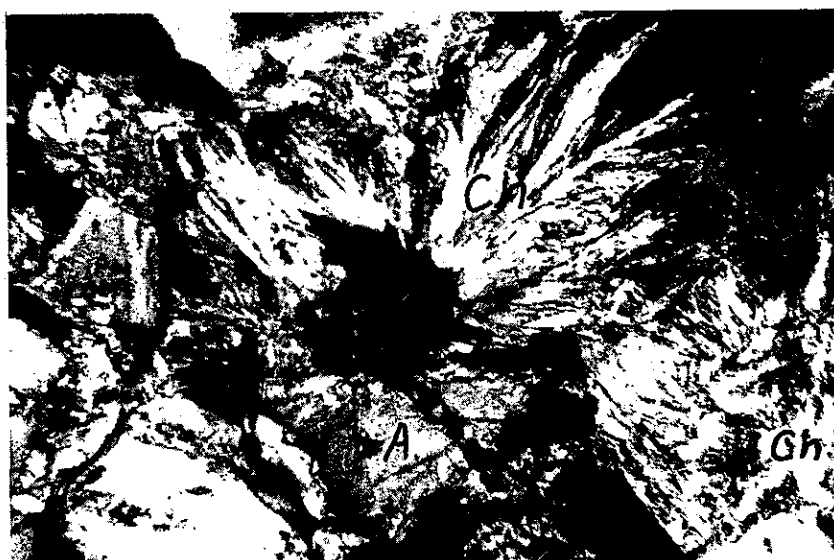
Photo 16 - Vera Miosi Quarry 65-2055 X 100
 Chloritized augite in radiating pattern.

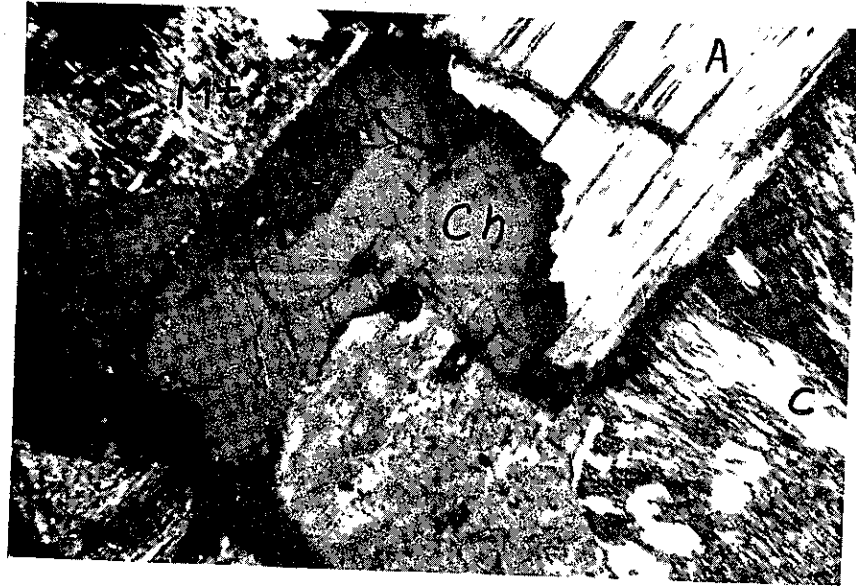
Results of the study (see Table 3) indicate that progressive alteration of the augite teschenite in this area leads to the formation of montmorillonite at the expense of the analcite and feldspar. It should be noted that there is nearly twice the amount of montmorillonite in the "pit run" sample as in the selective one. Physical test results were very poor, except for the SE, limiting use to aggregate subbase.

Photo 17 - Vera Miosi Quarry 65-2055 X 100
 Chloritized augite and analcite
 partially altered to montmorillonite.

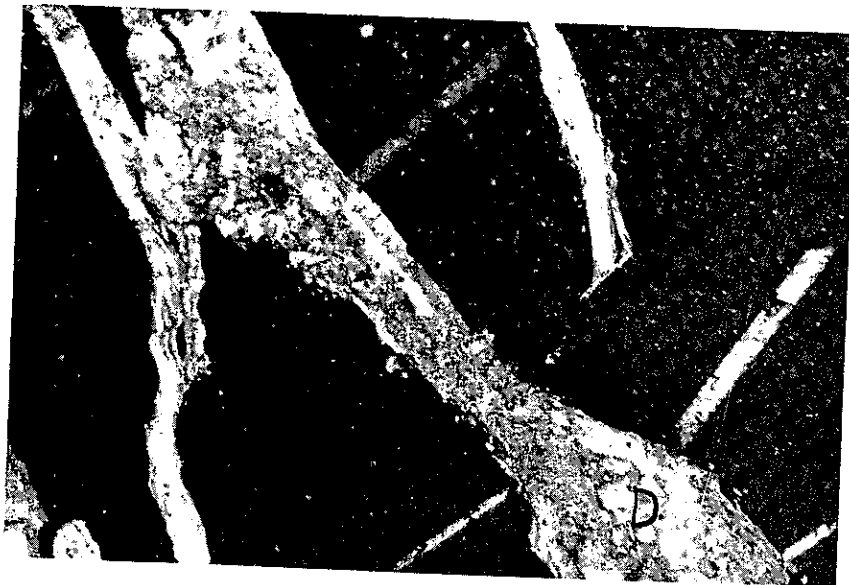
Photo 18 - Kaiser Refractory Plant waste pile
 65-4384 X 100 Veinlet of weathered
 dolomite in calcitic dolomite.

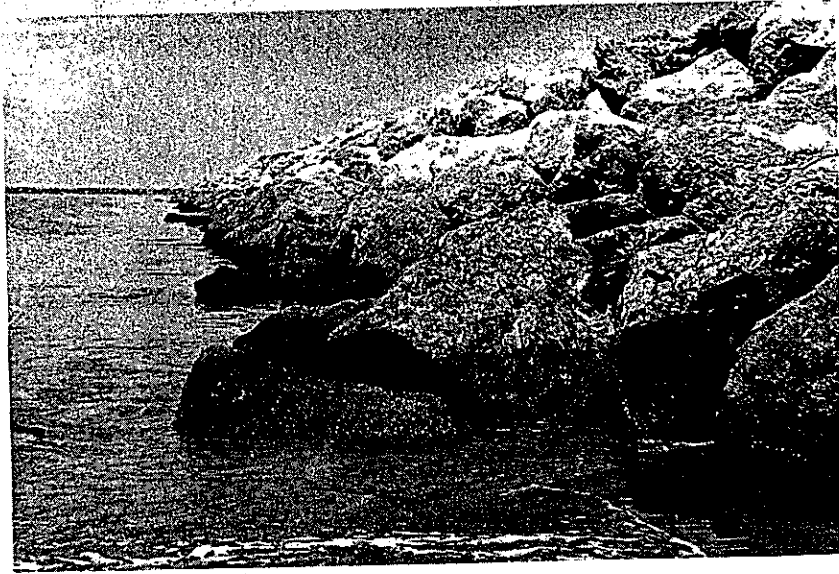
Two of the more interesting installations using volcanics from the Ventura County quarries are the Ventura County Small Boat Harbor located at Silver Strand and the Santa Clara River Levees, both Corps of Engineers projects. The first installation was constructed of Hawley Quarry rhyolitic volcanic agglomerate in 1956 (photo 19). Six to eight-foot diameter boulders placed around the perimeter of the harbor exhibit extensive weathering. The weathering, however, is largely confined to clasts contained within the matrix of the volcanic agglomerate (see Photo 20). Occasional cracks were noted in the fine-grained matrix where large clasts had weathered out suggesting the formation of an expansive product of weathering within a confined area or a weakness of the rock produced by the void. The former possibility was confirmed when X-ray and thin section analysis revealed a concentration of montmorillonite within the older clasts. Montmorillonite percentages ranged from 14 to 28 percent for the original samples sent in by the District (see Table 2).

Photo 19 - Ventura County Small Boat Harbor at Silver Strand. Volcanic agglomerate from Hawley Quarry.

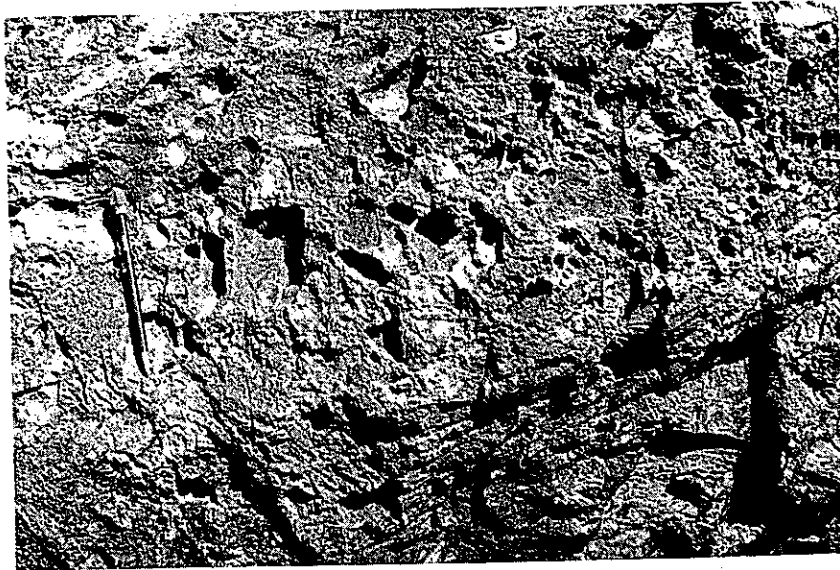
Photo 20 - Close-up of boulders in Photo 19. Note well defined weathering of clasts from the agglomerate.

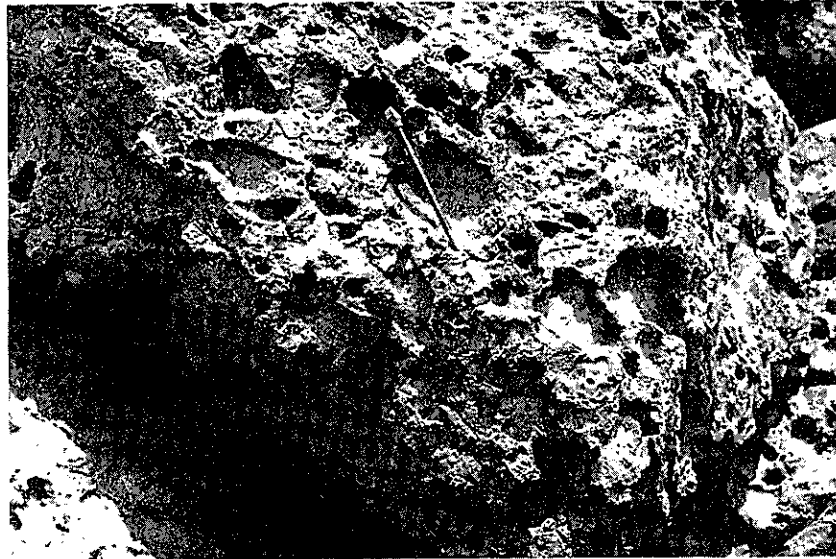
Rock slope protection from the same source was used along Road 07-Ven-101 at La Jolla Canyon Beach a few miles south of Point Mugu. This installation was also made in 1956 and is weathered similarly to that of the Ventura County Small Boat Harbor. Rounding of the boulders with less differential weathering was noted, however, where wave action was active on the beach (photos 21 and 22).

Photo 21 - Volcanic agglomerate from Hawley Quarry
used as rock slope protection on
La Jolla Canyon Beach. Note differential
weathering.

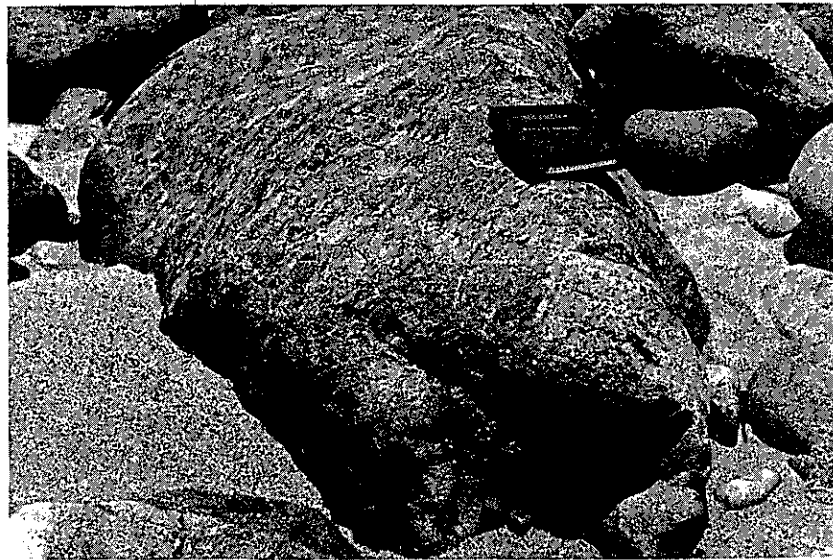
Photo 22 - Similar source and rock type as in
Photo 21, but exposed to wave action.
Note rounding, less differential weathering.
